Use of In-Situ Metallography for Plant Health Assessment Studies and Failure Investigations

Paresh U. Haribhakti
TCR Arabia LLC
Kingdom of Saudi Arabia
Email: paresh@tcr-arabia.com

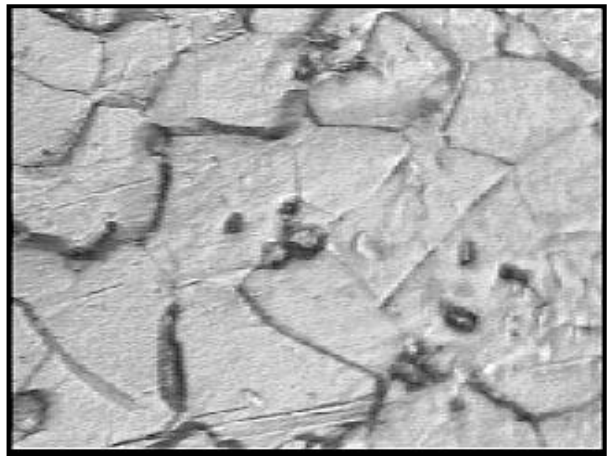
With all the precautions and safety measures, accidents do take place in process plants. Accidental fire damage is more common in refineries and petrochemical industries. The carbon and alloy steel components are normally analyzed by replica microstructure analysis. The components having intact pearlite are allowed for further use. Those having complete spheroidization of the pearlite are recommended for replacements. Those having partial spheroidization of the pearlite are recommended for further use with periodic monitoring through in-situ metallography. It requires great depth of metallurgical knowledge to judge the estimation of temperature based on physical metallurgy.

Figure 4 – Shows Microstructure of Plain Carbon Steel Material Showing the Grain Boundary Oxidation, Exposed to an Accidental Fire (400X)

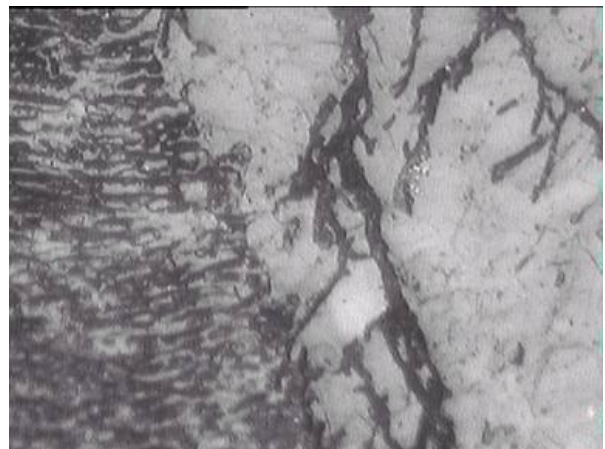
Figure 6 – Replicated Microstructure of 304 SS Reactor Showing Trans Granular Stress Corrosion Damage at HAZ (400X)

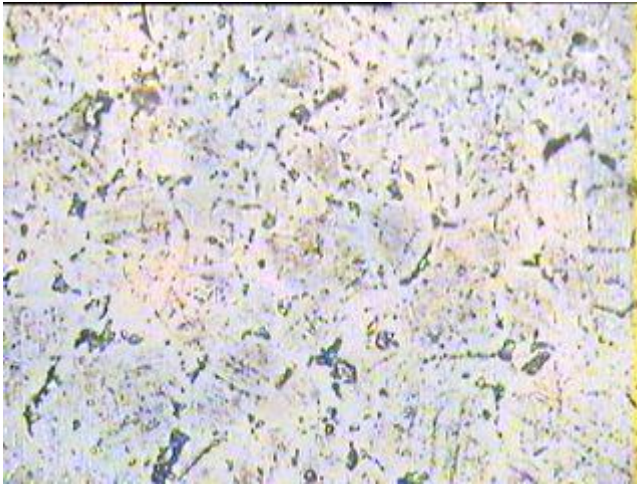
Stainless steels are normally used in refineries in the range of service temperature where they are susceptible to sigma phase formation. Normally, the temperature ranges between 580-960°C. Corrosion resistance is drastically reduced and its formation leads to brittle failure of the components during start up and shut down of the plant. In-situ metallography is effectively used to find out presence of sigma phase with electrolytic etching. If it is finely distributed spread uniformly in the microstructure, then it is less harmful. However, if sigma phase is concentrated in form of lumps it is highly detrimental – more so when inter connected. During shut downs, it can trigger onset of corrosion finally leading to leakage. The percentage of sigma phase can be calculated using automatic image analyzer software that aids in taking a decision whether the component is to be replaced or used further. Figures 6 & 7 show the microstructures indicating copious sigma phase formation after 8 years of service of SS 304H pipe in FCC service of refinery. 15-20% of sigma in the weld metal was judged as the criteria that increases the susceptibility towards cracking. However, the decision of replacement depends on the morphology of the sigma phase and cracking tendency of the weld.

Figures 6 & 7 are microstructures of SS 304H material showing presence of sigma phase formation at the grain boundaries and within the grains of parent metal and at inter-dendrite regions of weld metal.

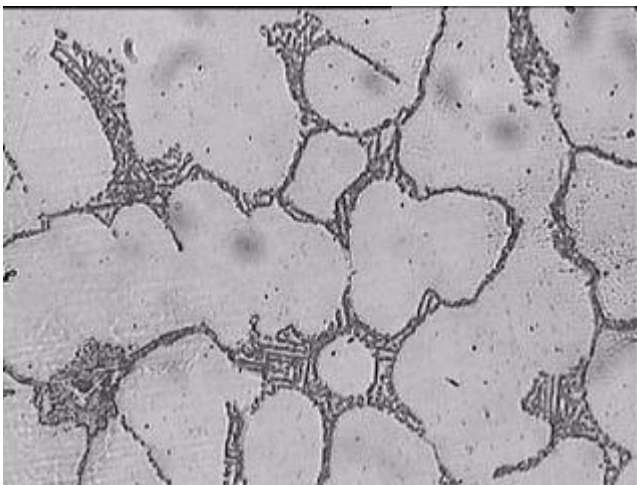
Figure 8 – Microstructure of HP Modified Alloy Shows Inter-Dendritic Network of Primary Carbides in the Matrix of Austenite. Presence or Secondary Precipitations including Carbides are Observed within the Matrix (400X).

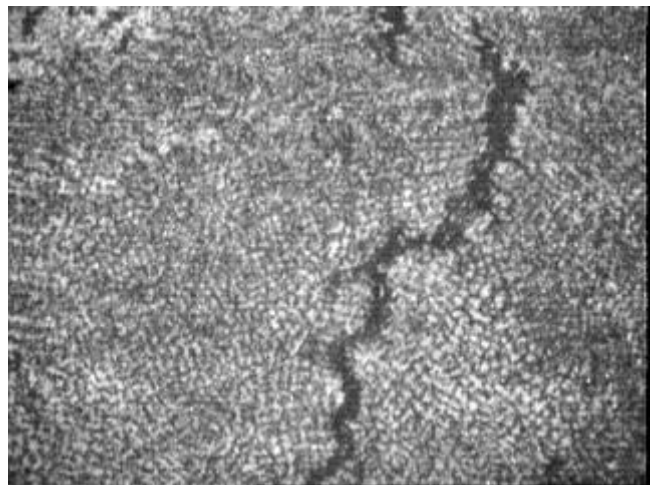
Reformer tubes are used in fertilizer industries, refineries and petrochemical industries either for hydrogen generation or reforming of hydrogen along with the steam. The tubes act as individual reactors for the reforming process. The specific failure mechanism involves creep generated mid wall fissures that progress towards the OD. Mid wall fissures that were noticed under conventional NDT test like UT, Radiography and Creep determination by OD measurements with judicious approach. In-situ metallography was used to determine whether the tubes can be used further or be retired immediately. Figures 8 & 9 are the selected microstructures of in-situ metallographs from a reformer tube of HP modified alloy; comparing control virgin tube microstructure versus the presence of micro cracks in a

used tube having 12 years of service completed. This indicated the final stage of creep life and the tube was retired from the service in order to avoid failures during service.

Figure 9 – Microstructure of HP Modified Alloy Shows Primary and Secondary Precipitates including Carbides. Coarsening of Secondary Precipitation Observed within the Austenitic Matrix. Micro Cracks are Observed. Carbides Present at Dendritic Regions (100X).

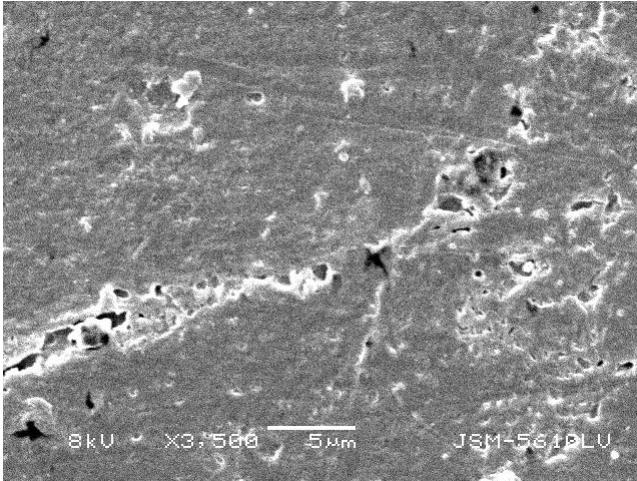
Boiler pressure parts like super heater tubes, steam pipes and headers are operating in the creep range and they are designed for certain minimum lifetime. These components deteriorate continuously during the service, as a result of time dependent material degradation process like creep, fatigue, corrosion and oxidation. The limiting factors for the components operating at high temperature and pressure are creep life. Creep life is considered exhausted when it reaches the macro cracks through cavitation stage. The damage takes place in four successive stages formation of cavities, alignment of creep cavities, micro cracks and macro cracks. One can find out the life fraction consumed by identifying the prevailing stage in the microstructure. The successive stages are no creep cavities, isolated creep cavities, oriented creep cavities and the final stage of micro-cracks. Next monitoring interval is based on the level of degradation observed. Observing under SEM after gold sputtering can have most reliable judgments. Figures 10 & 11 are SEM micrographs of the main steam line showing oriented creep cavities with initial stage of micro cracks. It was recommended to monitor the cracks after one year through in-situ metallography and start planning for the replacement in next two years.

Figure 10 – SEM Picture of Parent Metal of Microstructure of P11 Material Showing Oriented Creep Cavities at Grain Boundaries (X3500)

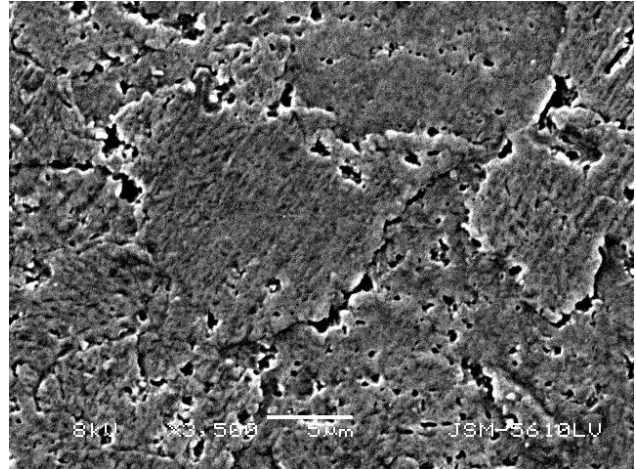
Figure11 – Microstructure of P11 Material Shows Initial Stage of Crack Formation at the Grain Boundaries (3500X)

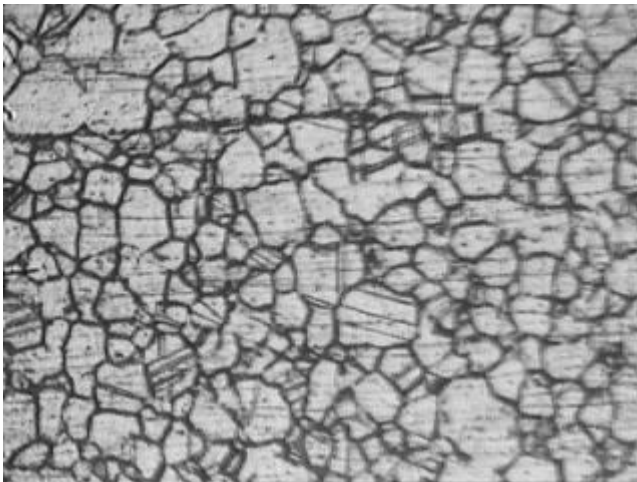
Austenitic Stainless steels are extensively used especially for high temperature and corrosion resistance applications. Carbide precipitation is more common while it undergoes processes like hot working and welding and during operation. Alloys are supplied in solution annealed condition where the carbon remains completely dissolved in austenite matrix and there is no carbide precipitation at the grain boundaries for better corrosion resistance. During the course of service or improper manufacturing it may undergo damage by way of precipitation of carbides at the grain boundaries. This can be easily detected by adopting in-situ metallography technique which can also assess the extent of damage. Figures 12 & 13 show presence of chromium carbide precipitations at the grain boundaries and is termed as ditch structure. Such material is susceptible for IGC (Inter-granular corrosion) and IGSCC (Inter-granular stress corrosion cracking) attack under favorable conditions.

Figures 12 and 13 shows sensitized microstructure of Type 316 stainless steel indicating heavy carbide precipitation at the austenite grain boundaries.
